Manhole Inspection Summary

Manhole # S51M__003MH

Insp Date: **4/14/08 9:39 AM**

Location Address: **820 fait-hudson**

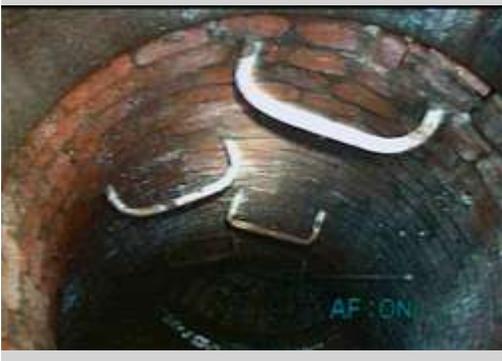
Defect 2

Steps Count: **5** Missing: **0** **Corroded**

steps

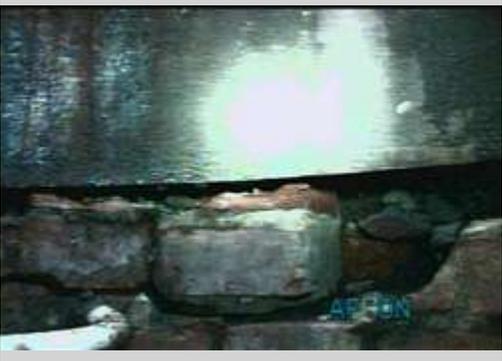
Defect 1

Condition: Sound Cracked Root Intrusion **Loose Brick** Deteriorated

corbel

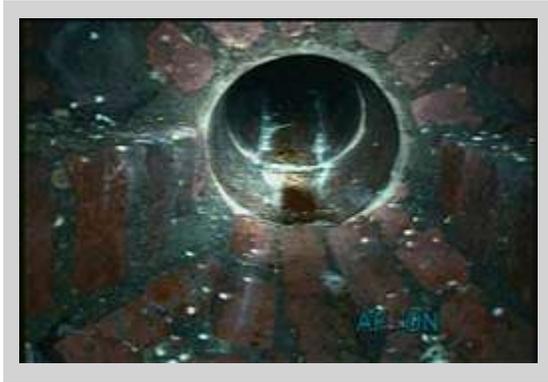
12 O'Clock Outflow

8 in. Circular Gravity Sewer
Pipe Out @ 12 O'Clock

Pipe Height: **0** (in.) Direct
Pipe Material: **Clay** Pipe Lined
Invert Depth: **8.63** (ft.) Flow Characteristics: **Slow**
Deposits: None Mud Sludge Debris Grease
Silt Depth: **0** (in.) Deposits Extent:
Infiltration: **None** Pipe Seal Cond: **Unknown**

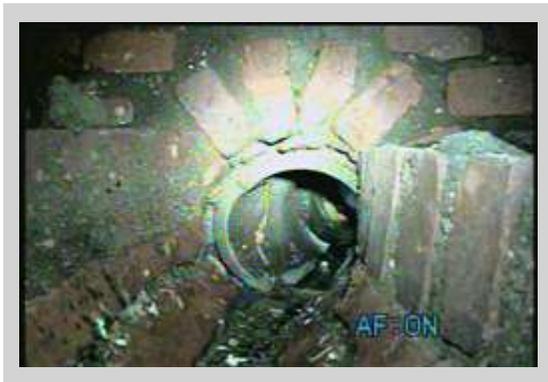
3 O'Clock Inflow

8 in. Circular Gravity Sewer
Pipe In @ 3 O'Clock

Pipe Height: **0** (in.) Direct
Pipe Material: **Clay** Pipe Lined
Invert Depth: **8.46** (ft.) Flow Characteristics: **Slow**
Deposits: None Mud Sludge Debris Grease
Silt Depth: **0** (in.) Deposits Extent:
Infiltration: **None** Pipe Seal Cond: **Unknown**

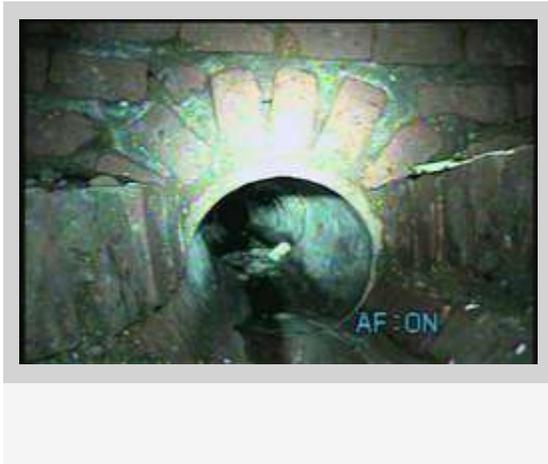
9 O'Clock Inflow

8 in. Circular Gravity Sewer
Pipe In @ 9 O'Clock

Invert Depth: **8.50** (ft.) Flow Characteristics: **Slow**

Connects To: **House connection / Service line**
